JACQUES WHITFORD COMPANY, INC.

SITE LOCATION MAP FORMER DEPOT ENERGY SITE 13 DEPOT STREET WINDHAM, MAINE

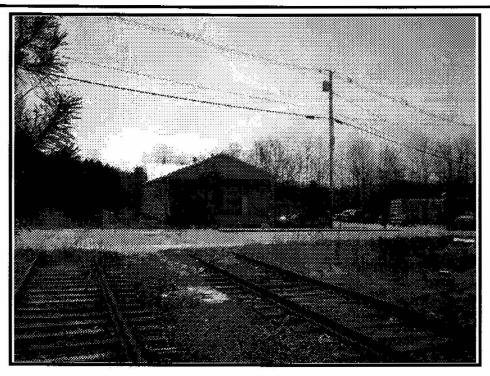
1. Subject Site from across Depot Street.

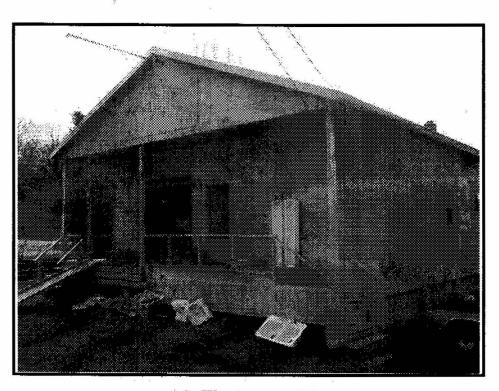
2. Warehouse building.

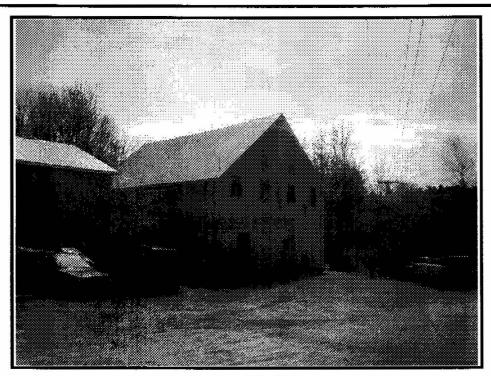
3. Garage building.

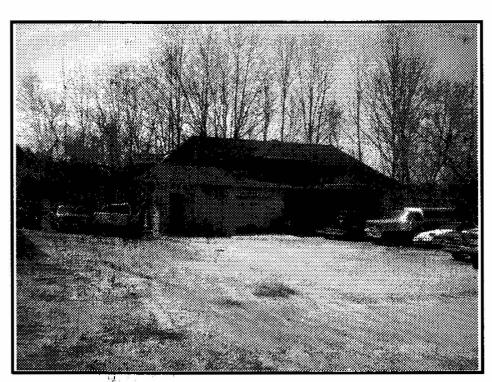
4. Storage building/former railroad station with junked autos to the left and right.

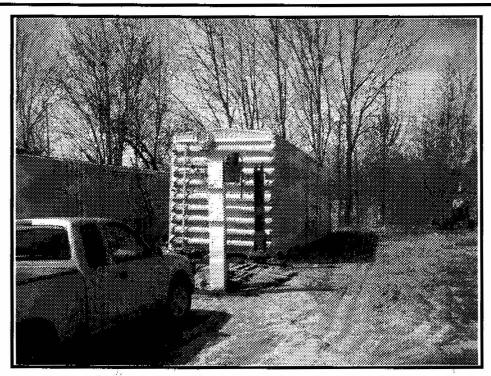
5. Boxcar used for storage of used transmissions.

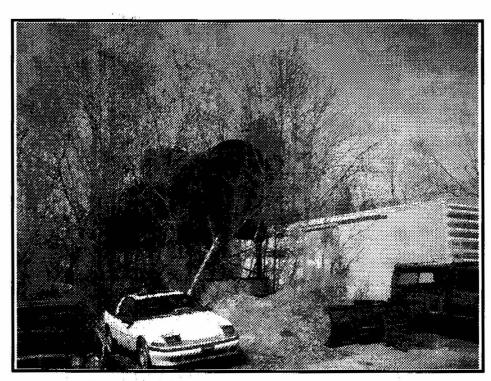
6. 10,000 gallon aboveground storage tank (former rail car).

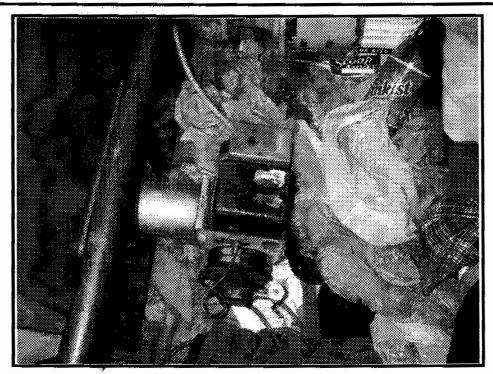
7. Oil burner in warehouse building.

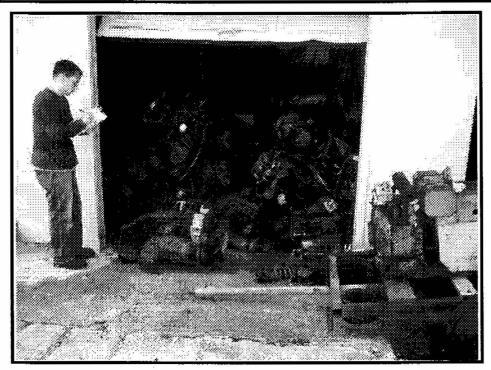
9. Transmissions in storage building (former train station).

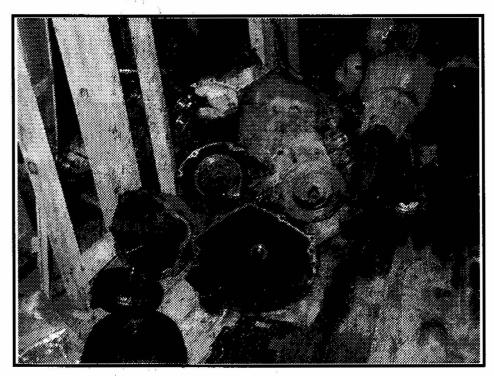
10. Used transmissions stored in warehouse building.
